FAILURE ANALYSIS HANDBOOK

C. R. Walker, K. K. Starr

Pratt & Whitney
P.O. Box 109600
West Palm Beach, FL 33410-9600

August 1989

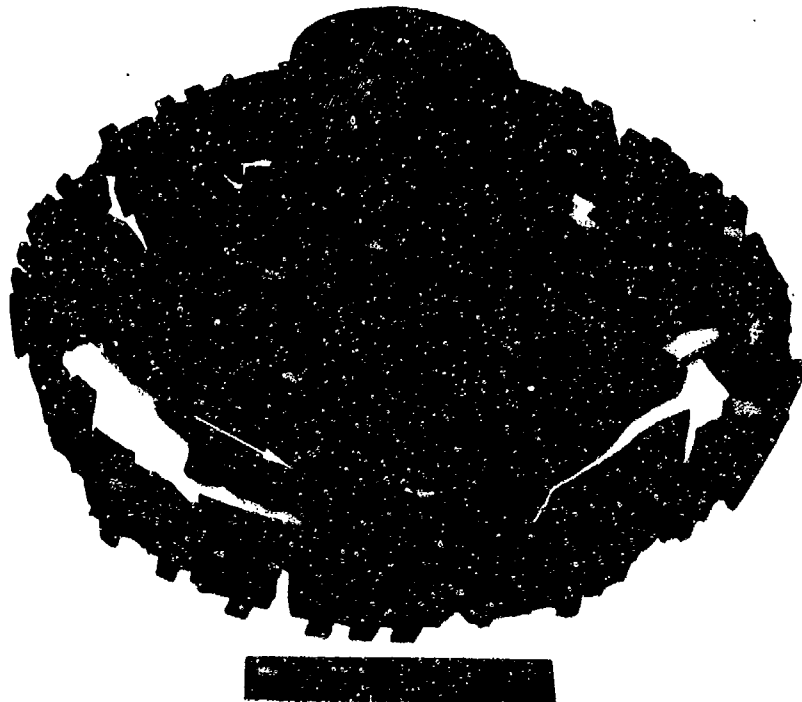
FE 255662

FIGURE II-4: Reconstructed compressor disk that fractured during cryogenic proof testing. The directions of fracture propagation (black arrows) were marked on each fragment before reconstruction so a map of fracture progression could be used to identify a primary origin area (white arrow).

Fracture mapping is a technique often employed to help analyze complicated failures of structures like bridges, pressure vessels, aircraft airframes, composites and rocket motor cases. Chevron marks or other fracture features are used to determine macroscopic fracture directions on individual fragments and these are combined on an overall map of the fracture. This map hopefully will show the fracture emanating from a primary origin area. The usefulness of this technique is illustrated in Figure II-4, a photograph of a reconstructed titanium alloy compressor disk that burst during proof testing at cryogenic temperature.

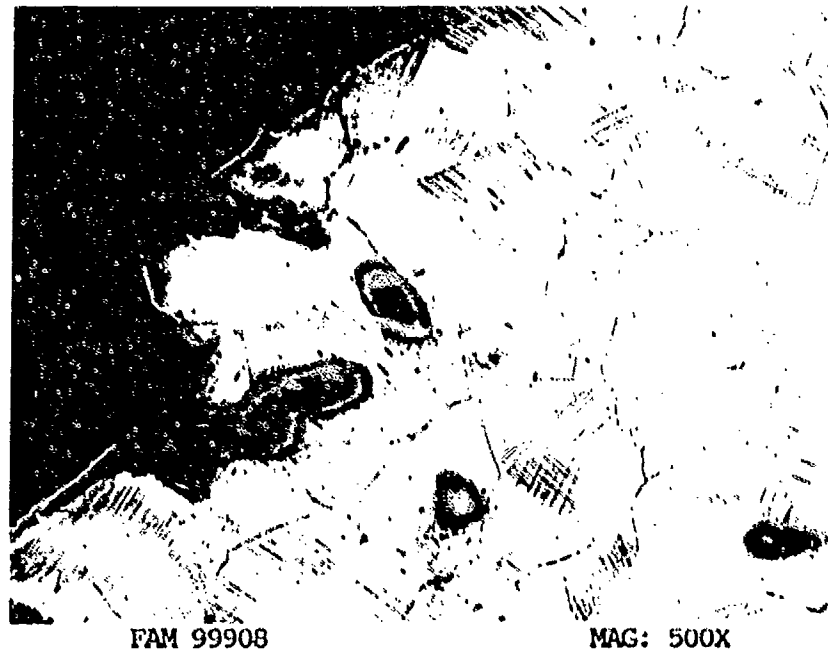
FIGURE II-9: Strain lines associated with an LCF fracture.
Etchant: Kalling's Reagent

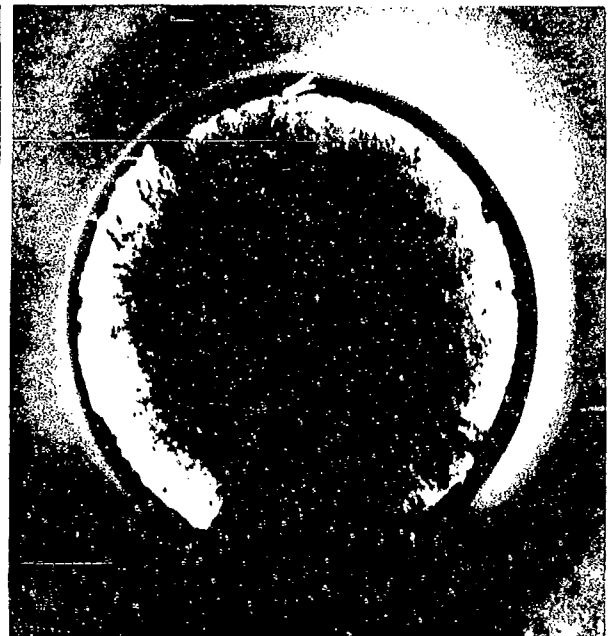
FAL 92553

FIGURE III-6: Dimpled overstress of fracture exhibiting no clear origin area.

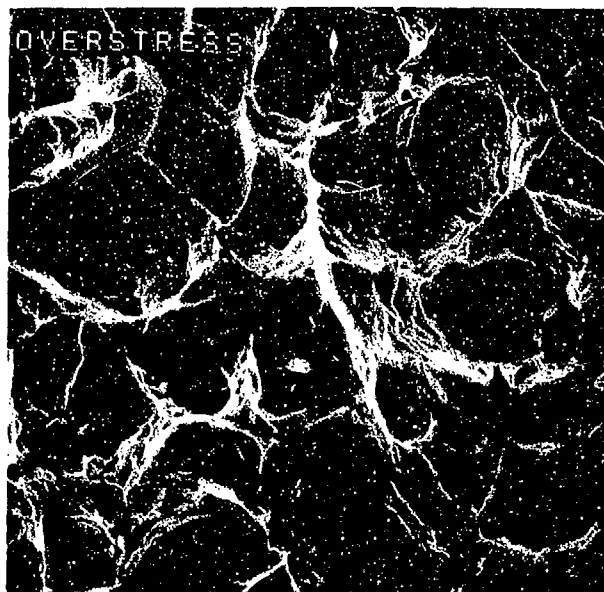
FAM 99532

FIGURE III-8: Coarse dimpled overstress.

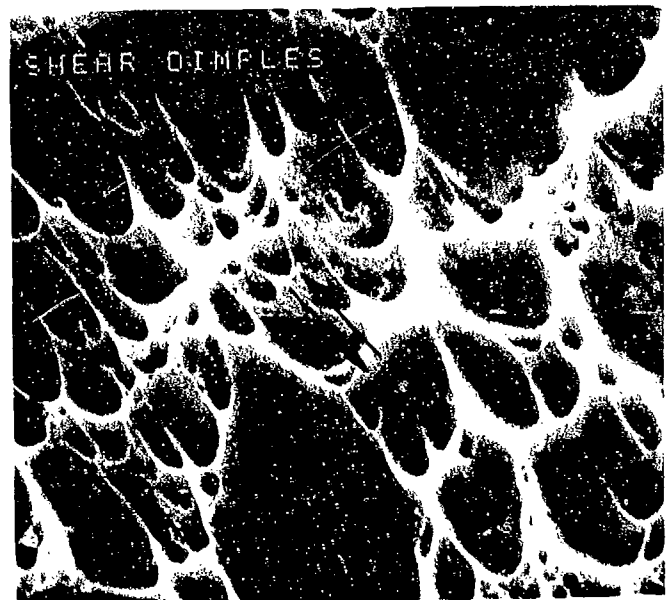
FAM 98532

FIGURE III-11: Elongated shear or tearing dimples exhibiting an open end. The directions of relative motion is shown by arrows.

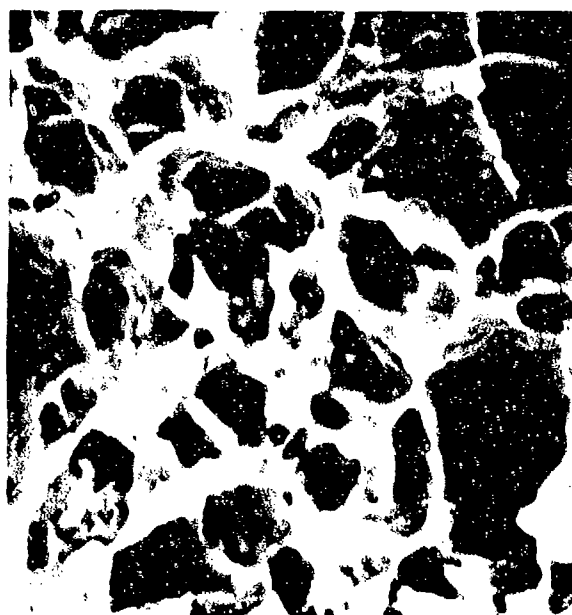
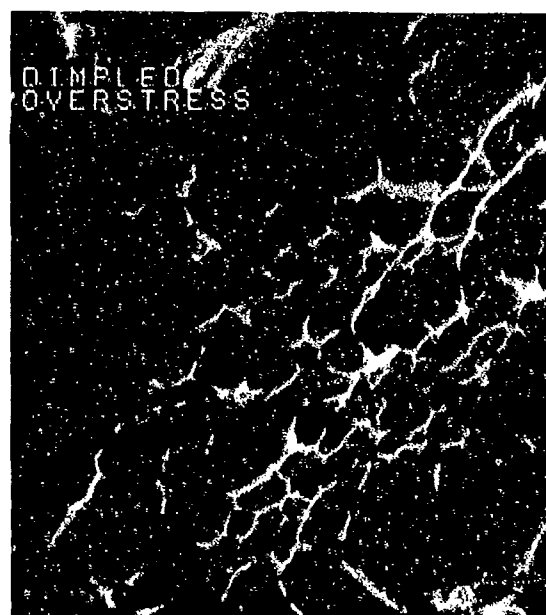
FIGURE III-13: Deep conical dimples (left) and shallow dimples (right).

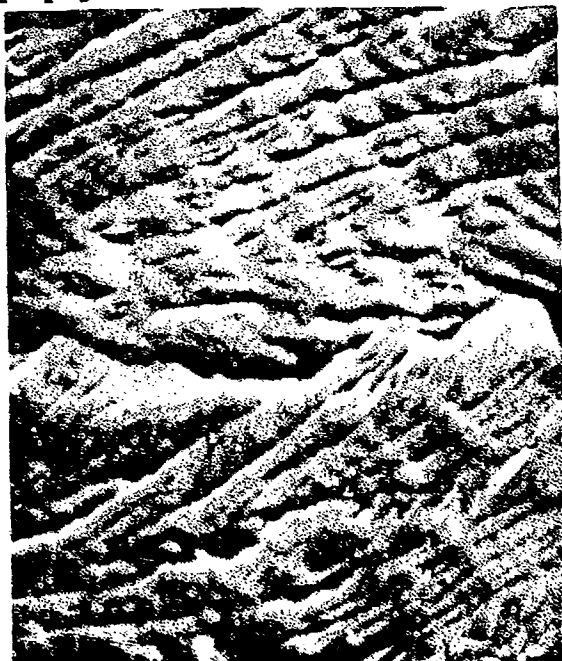
FAM 99363

FIGURE III-18: A river pattern formed when a series of cleavage planes join. The steps separating these planes form a pattern resembling a river system.

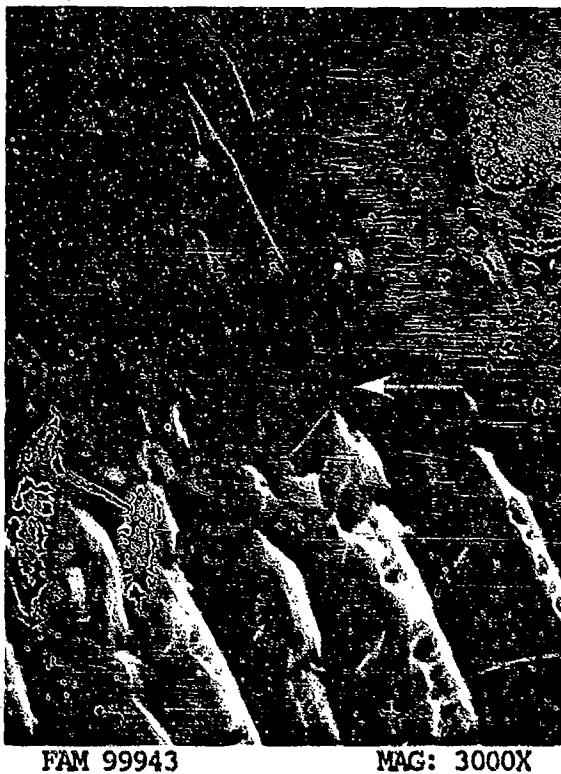
FAM 99943

FIGURE III-21: Cleavage steps propagating across a tilt boundary (arrow).

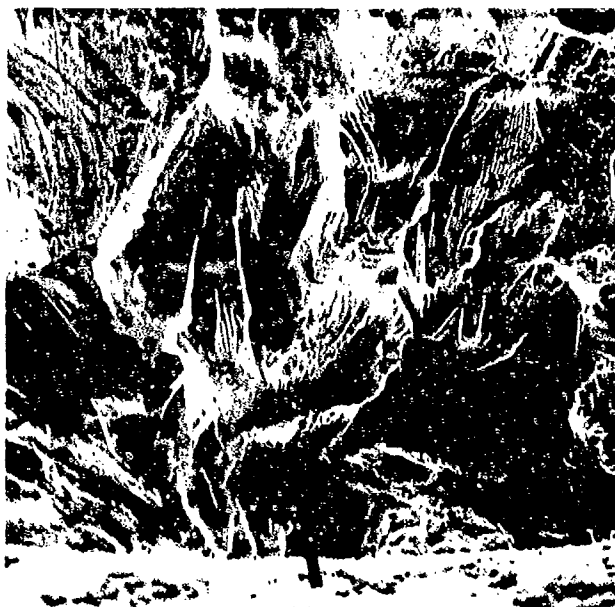
FAM 99201

FIGURE III-29: Typical stage I fatigue appearance, exhibiting facets and feathery cleavage (arrow).

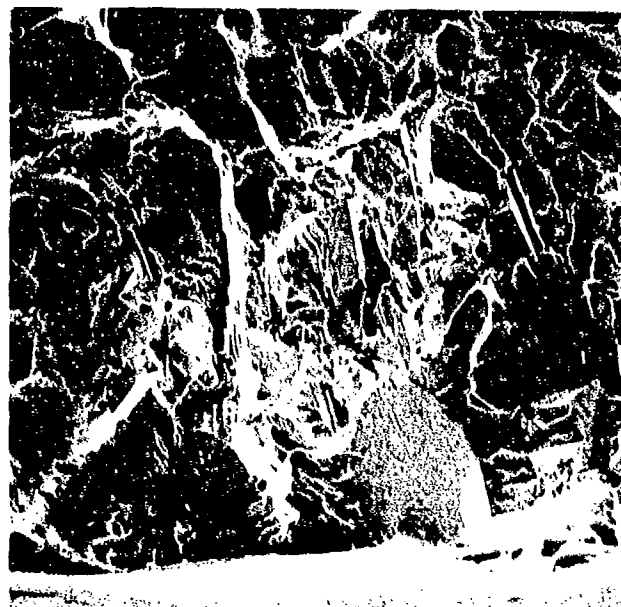
FAM 98656

FIGURE III-30: Alternate stage I fatigue appearance. A facet is shown by an arrow.

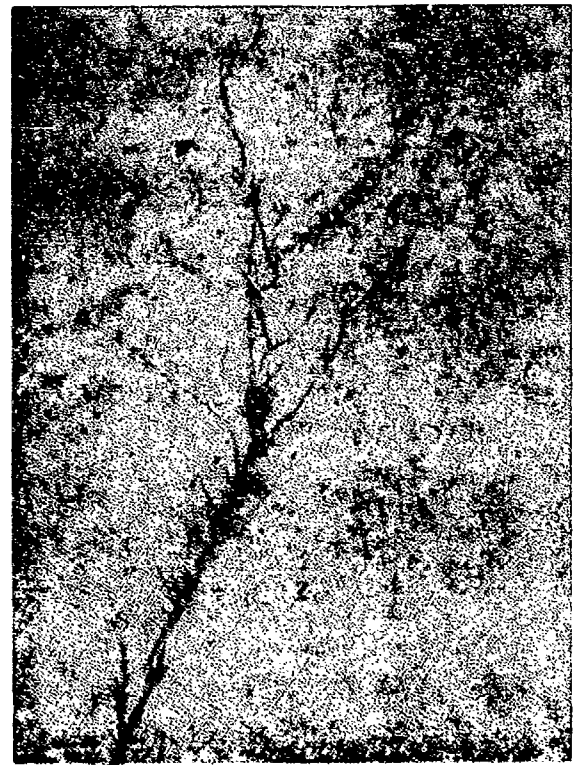
FAM 99951

FIGURE III-49: Metallographic cross section through a stress corrosion crack. The branching appearance is a distinguishing characteristic of SCC.

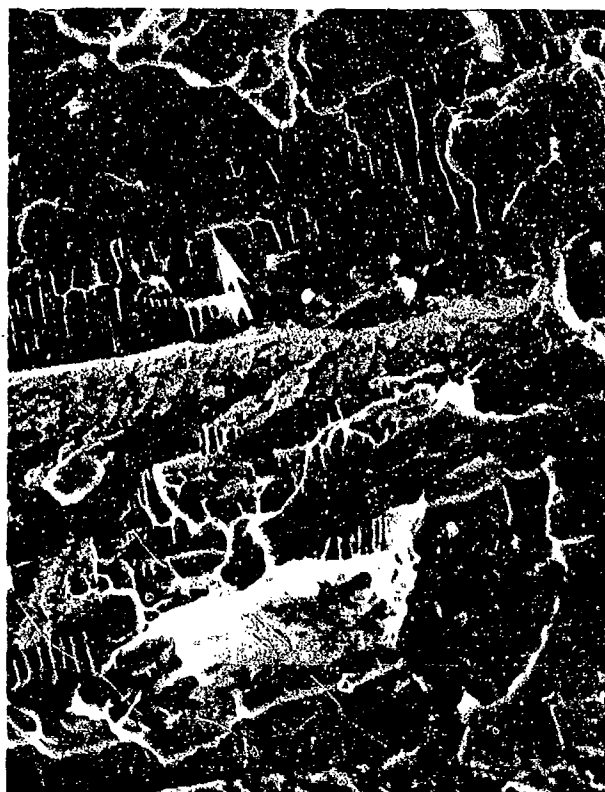
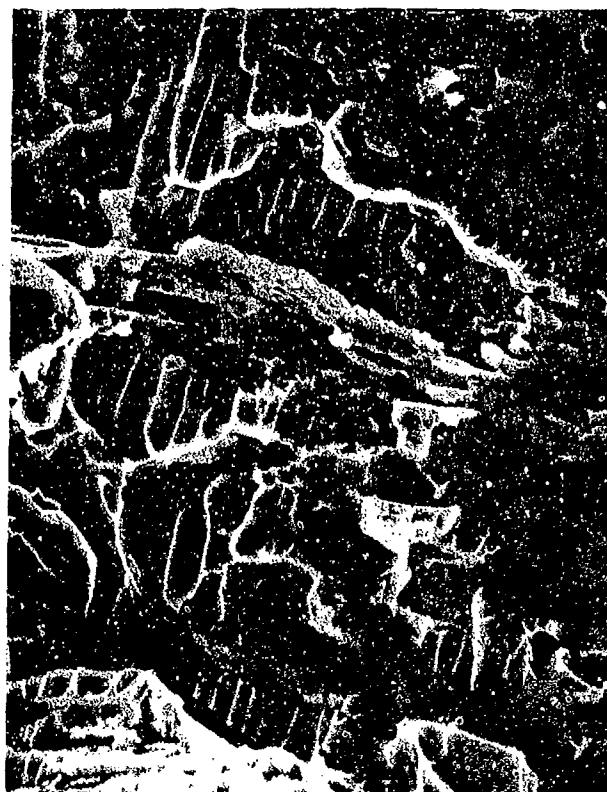
FIGURE III-50: Flutes (arrows) appear as ruptured tubular voids, usually oriented parallel to the stress axis. They can be well defined (left) or sporadic and hard to recognize (right).

Flutes are thought to be produced by the rupture of tubular voids formed by a planar slip mechanism. The presence of flutes has been used to distinguish SCC from other potential decohesive rupture mechanisms in titanium-base alloys. Figure III-50 illustrates the appearance of flutes. Flutes have also been observed under cryogenic testing conditions of Ti-based alloys.

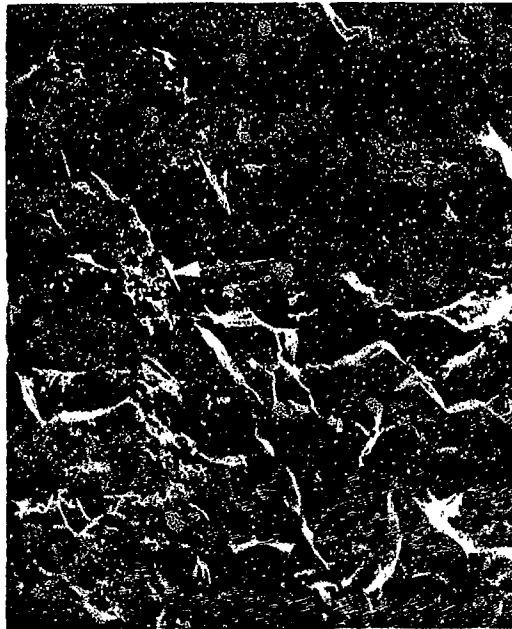
FAL 93333

FIGURE III-51: LME fracture surface exhibiting intergranular fracture through silver-base braze alloy that had penetrated the grain boundaries (arrow).

Embrittlement by a metallic species occurs when a low-melting-point alloy penetrates the grain boundaries of a structural alloy. The alloy may then fracture intergranularly at a stress lower than its normal yield stress. Liquid metal embrittlement occurs when a metal is exposed to the low-melting-point alloy in the liquid state while under tensile stress. Certain iron-base, nickel-base, titanium, and aluminum alloys can be embrittled by lead, tin, gallium, indium, mercury, cadmium, lithium and silver in the liquid state. A more limited group of alloys are susceptible to embrittlement when the embrittling metal is in the solid state. This is known as solid metal embrittlement (SME). Stress alloying is a term occasionally applied to both LME and SME. Figures III-51 and III-52 show typical LME fracture surfaces.

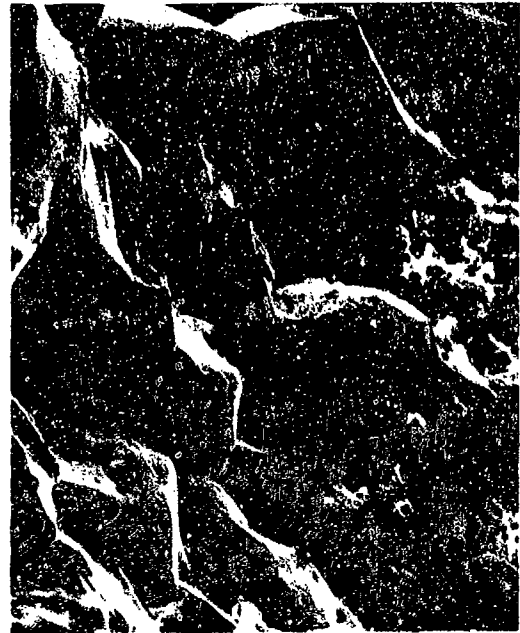
FAM 93332

FIGURE III-52: Higher magnification view of LME fracture surface.

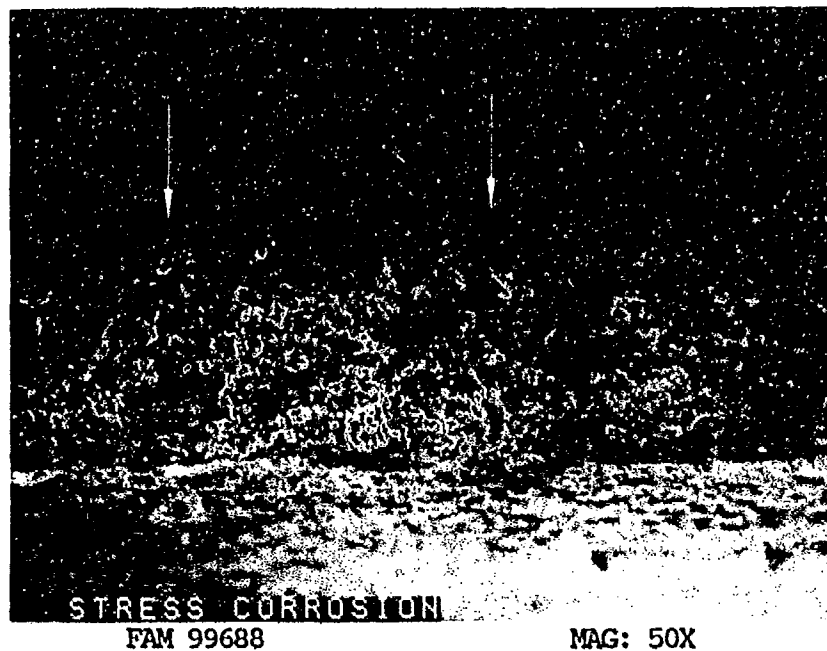
FIGURE 2-3: Low magnification photograph of the fracture surface exhibiting intergranular features. The final overstress area is visible as a thin band at the upper edge of the specimen (arrows).

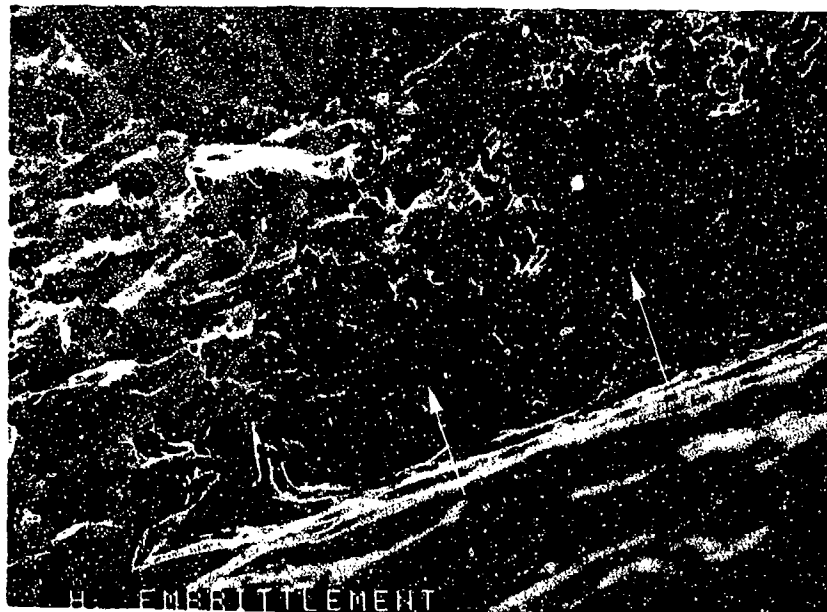
FIGURE 2-11: Possible remnant cleavage features at the edge of the specimen (arrows).

Only two tests were conducted on 15-5 PH: stress corrosion and hydrogen embrittlement. The stress corrosion test was conducted on a U-bend specimen in a 3.5% NaCl vapor at 95 C (203 F). The test temperature was chosen to accelerate the fracture. The specimen fracture surface was classical intergranular, originating on the tension side. This was determined by looking at corrosion deposits both on the surface of the specimen and on the fracture surface. A thin shear lip was present along the compression surface. The metallographic section confirmed the intergranular nature of the fracture and revealed branching intergranular secondary cracks characteristic of SCC. The hydrogen embrittlement specimen was charged for 12 hours in gaseous hydrogen then tested under static tension loading conditions in air. The specimen was tested at a stress of 244 ksi for 99.3 hours at which point the stress was increased to 273 ksi. Fracture occurred after 0.7 hours at this higher stress. The fracture surface was primarily dimpled overstress with secondary cracks. A narrow shear lip possibly containing remnant cleavage features was visible at the base of the notch.

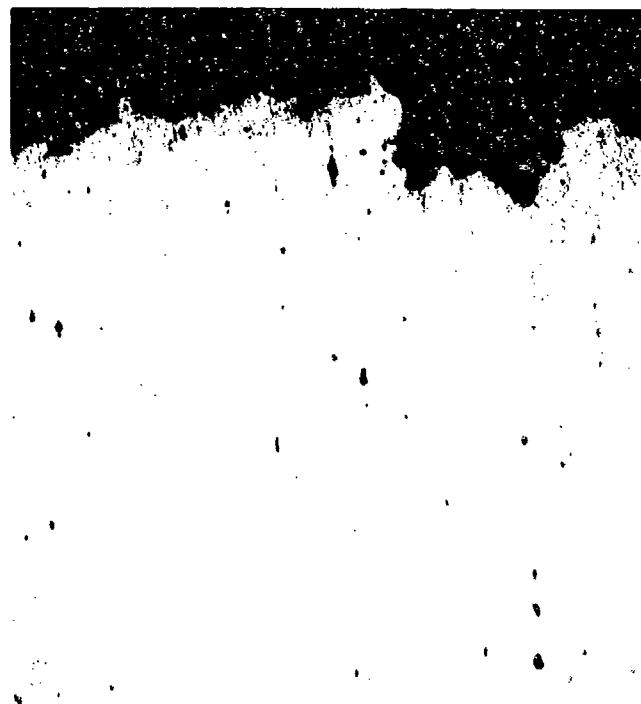
FIGURE 3-2: Optical photomicrographs showing the shear lip and deformation at the edge of the specimen (top). The shear lip is shown by an arrow. The center of the specimen exhibits transgranular overstress (bottom).

Etchant: Vilella's Reagent

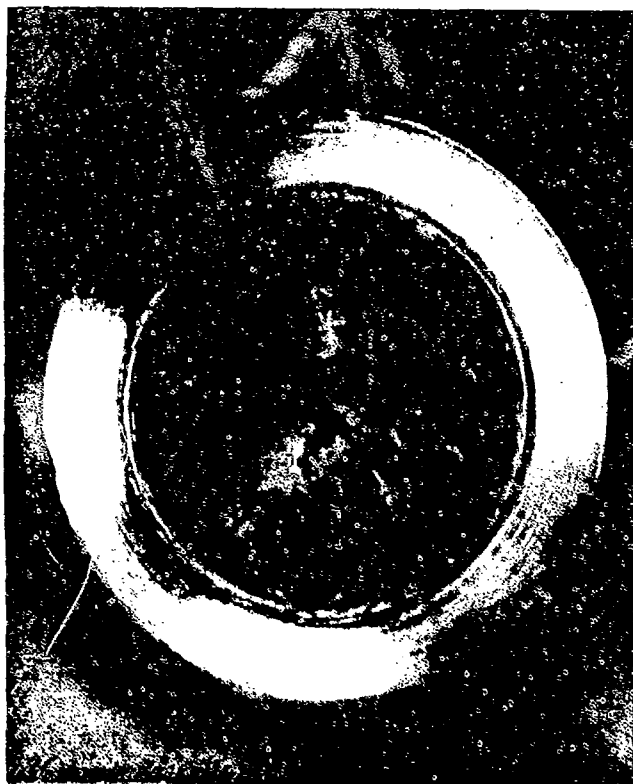
Figure 4-16: Test results and fractography of 347 SST room temperature notched tensile test. Three large secondary cracks radiate from the center of the specimen fracture surface.

Figure 4-25: Test results and fractography of 347 SST 816°C (1500°F) notched tensile test. This specimen fracture exhibits more depth in the features than the room temperature specimen (Figure 4-16).

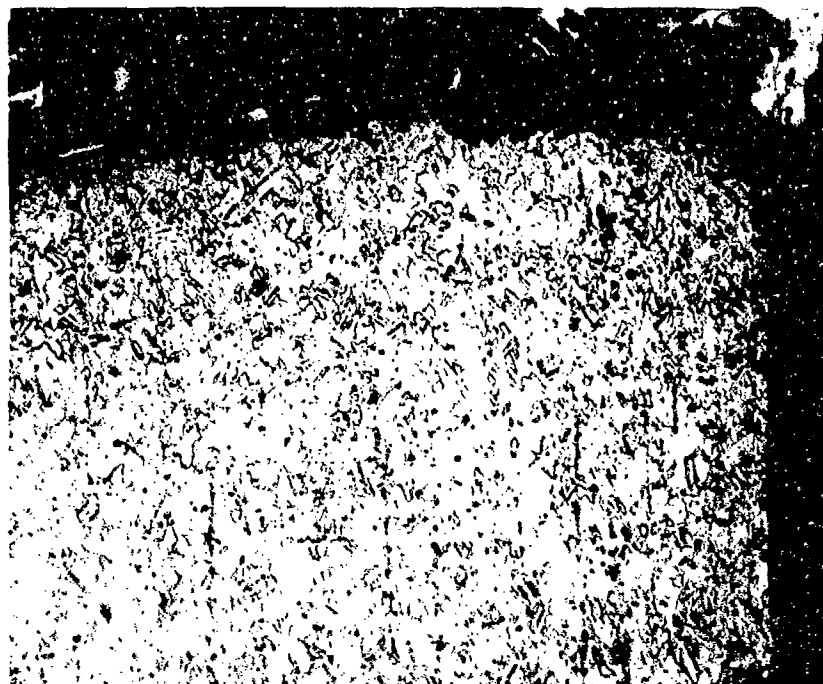
FIGURE 4-58: Optical photomicrographs of a metallographic cross section through the fracture surface. The fatigue progression is flat (transgranular) and occurred on a plane perpendicular to the stress axis (top). Grain elongation is visible in the final overstress area (bottom).

Etchant: 10% Oxalic acid electrolytic

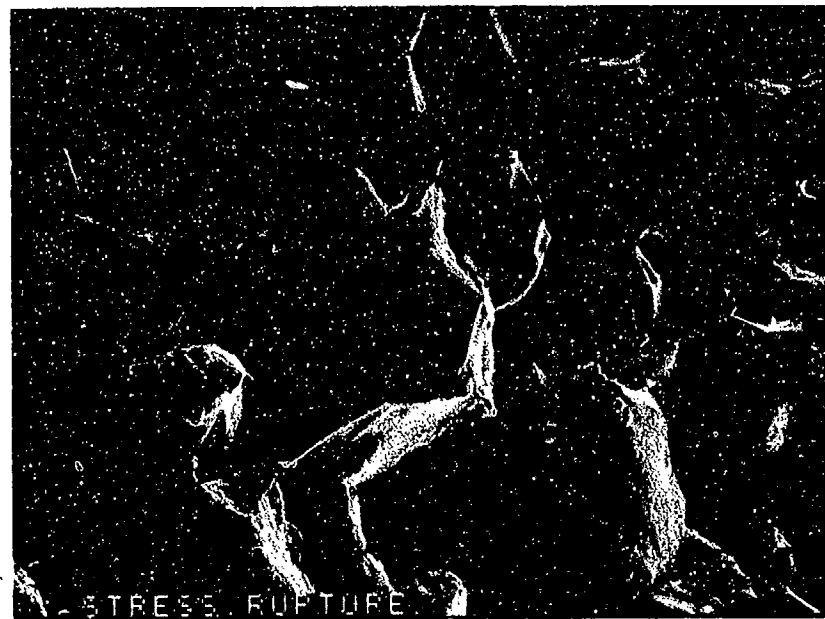
FAM 99537

FIGURE 5-31: Intergranular rupture with intergranular secondary cracking.

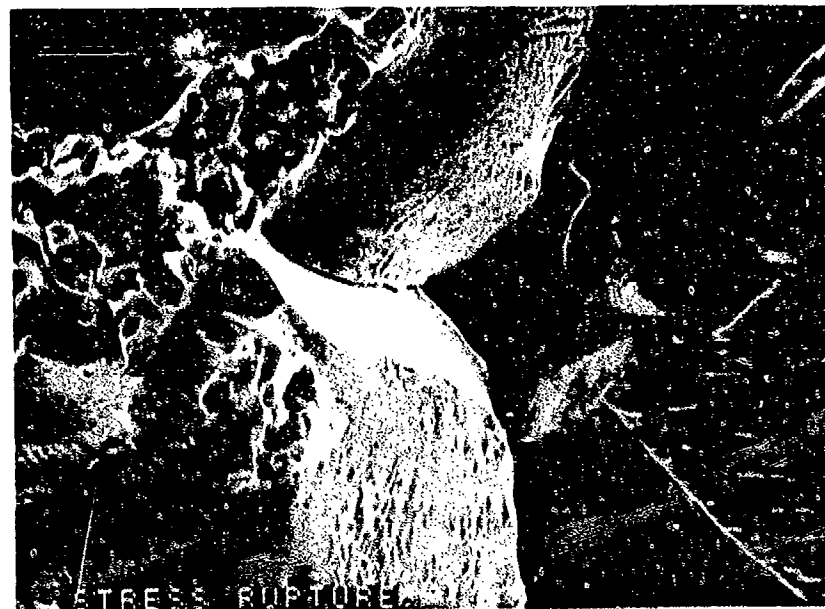
FAM 99538

FIGURE 5-32: Higher magnification photograph of the area shown in Figure 5-31, depicting intergranular rupture.

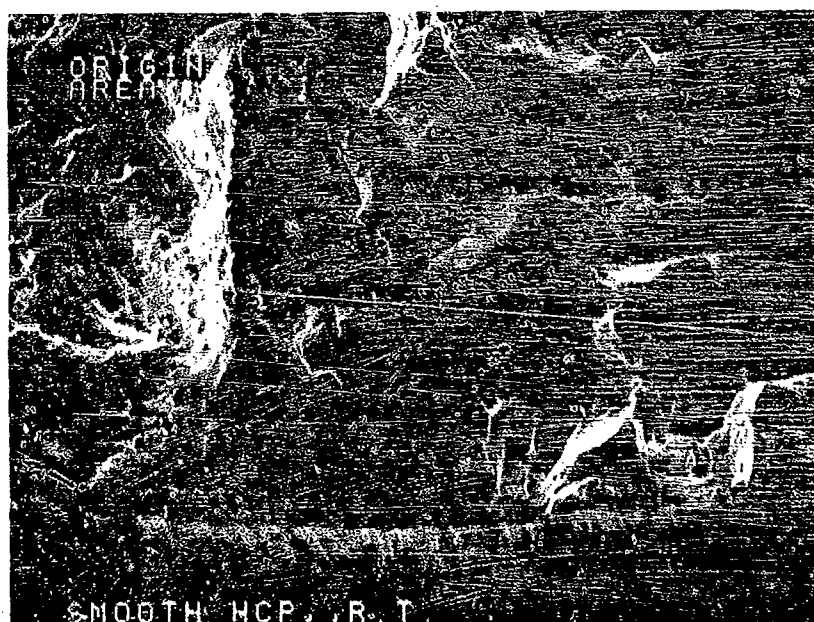
FAM 99183

FIGURE 5-38: Higher magnification photograph of the stage I fatigue facet (arrow) shown in Figure 5-37.

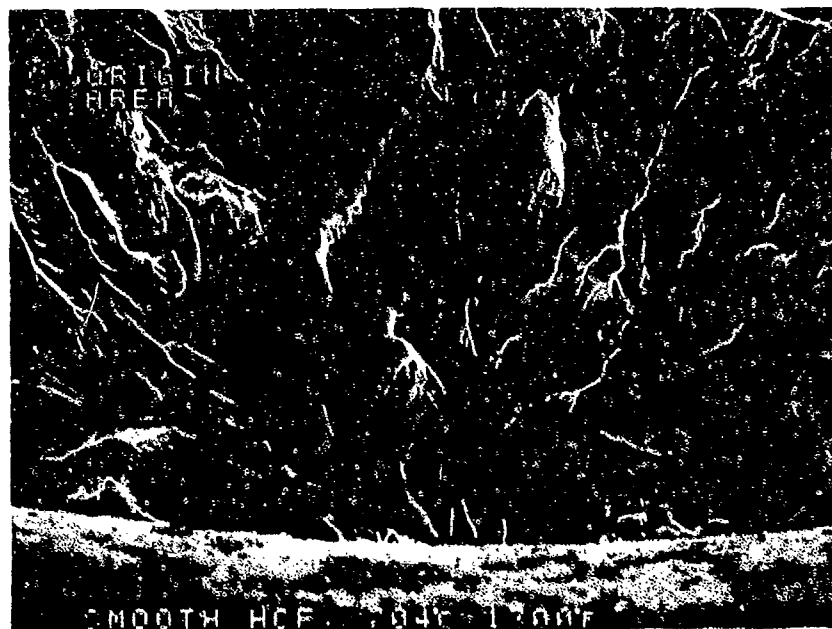
FAM 99201

FIGURE 5-56: Localized origin with stage I faceting. Feathery cleavage (arrows) is visible just back from the origin.

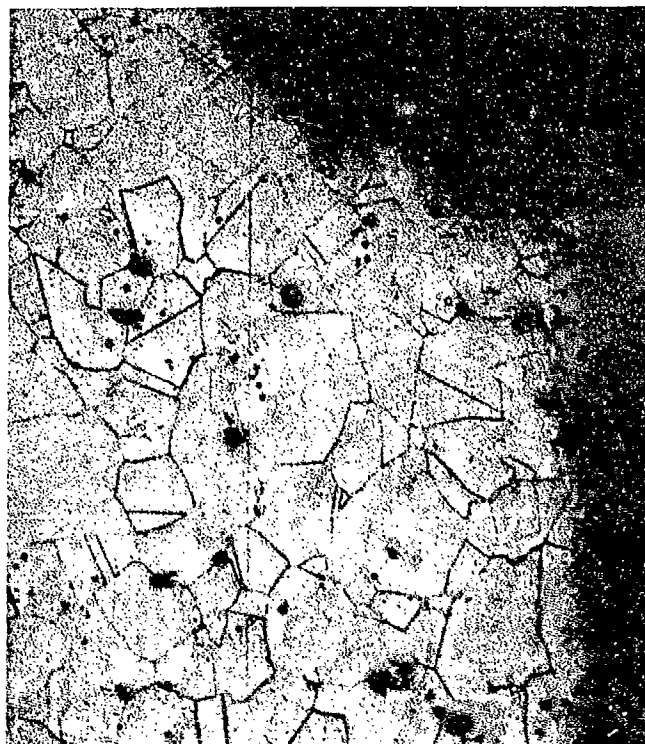
FIGURE 5-62: Optical photomicrographs showing the transgranular fatigue progression and secondary cracks (top) and the final overstress (bottom). The final overstress area exhibits numerous subsurface secondary cracks (arrows). No strain lines are visible.

Etchant: 15ml HCl, 10ml HNO₃, 10ml acetic acid

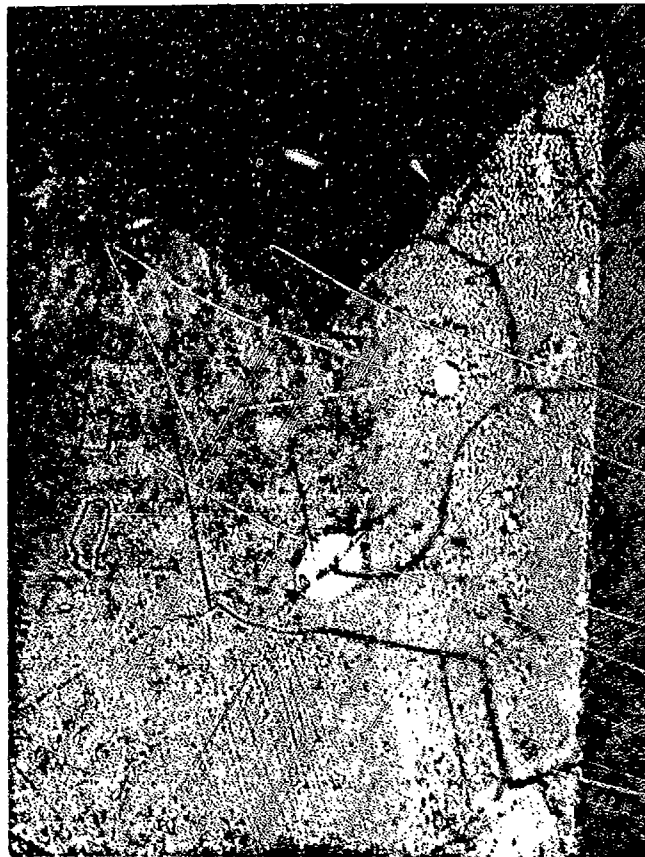
FIGURE 6-2: Optical photomicrograph showing the faceted, transgranular fracture path at the fatigue origin (arrow).

FIGURE 6-12: Optical photomicrograph showing a faceted intergranular fracture path near the center of the specimen. The grain boundaries are weaker at high temperatures. Compare with Figure 6-2.

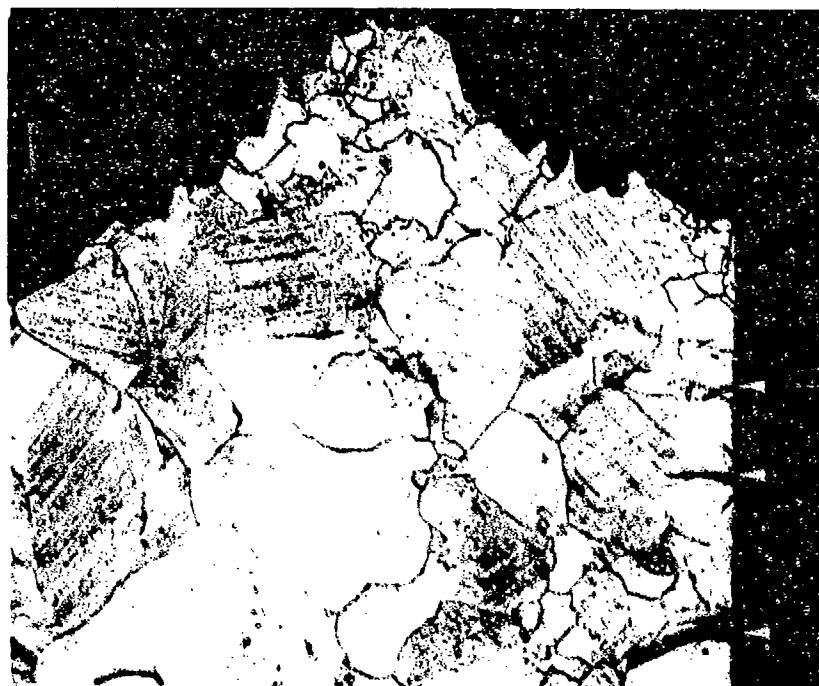
FIGURE 6-22: Optical photomicrograph showing a portion of the final overstress region. Three secondary TMF cracks are visible at the surface (arrows). Slip bands are visible in most of the grains, appearing as fine parallel lines.

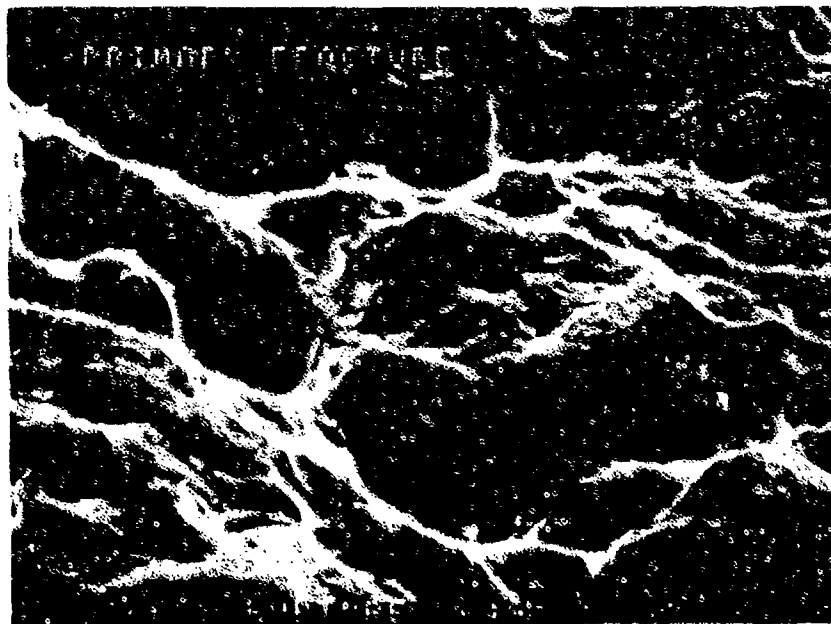
FAM 98263

FIGURE 7-34: Moderately oxidized primary fracture area.

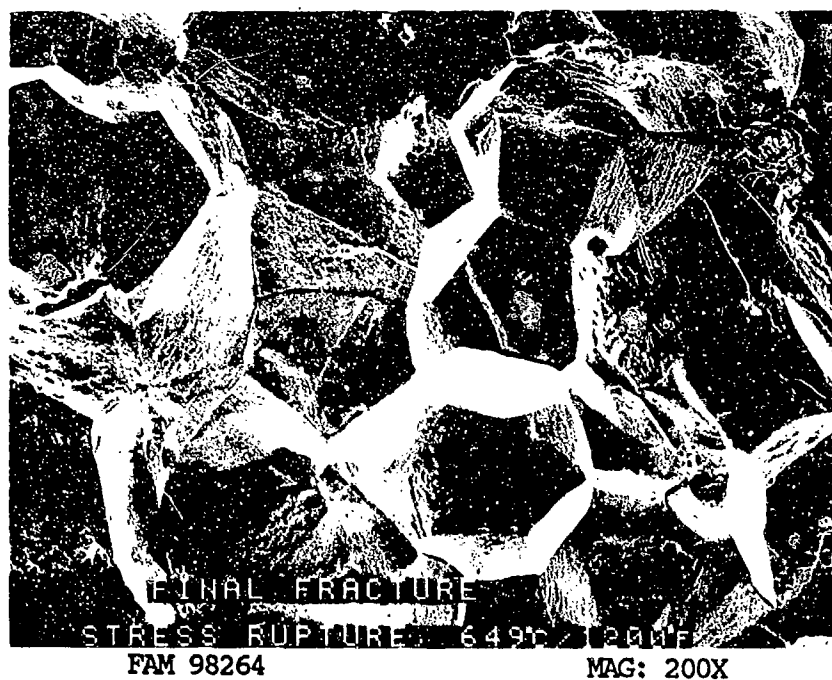
FIGURE 7-35: Intergranular overstress with some grain boundary separation in the final fracture area. The fracture surface is only lightly oxidized.

FIGURE 7-36: Higher magnification photograph of a grain boundary quadruple point (arrow) in the final fracture area shown in Figure 7-35.

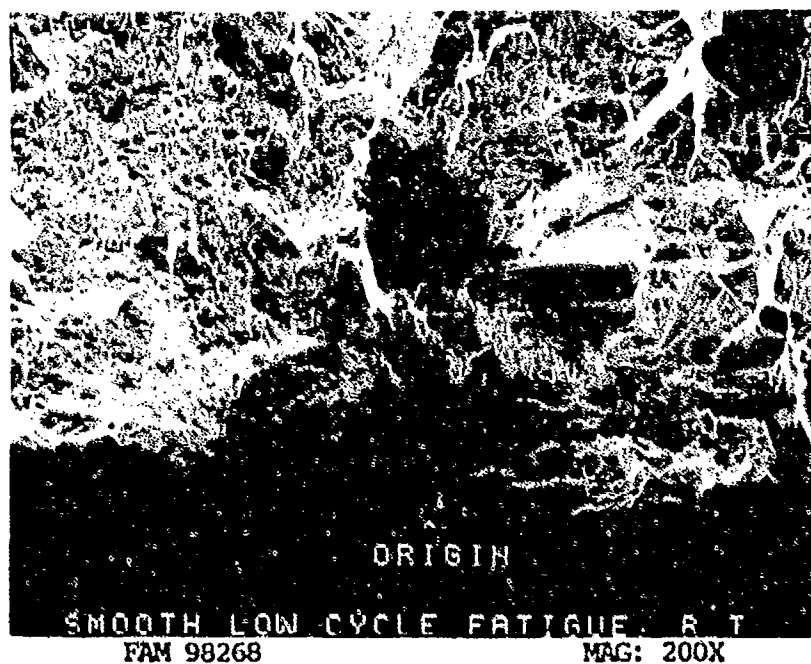
FIGURE 7-39: Low magnification view showing a fatigue origin. Fatigue propagation occurred in small patches near the surface of the specimen. The remainder of the fracture surface is a mixture of transgranular and intergranular overstress (mixed mode). Brackets show the extent of the fatigue.

FIGURE 7-40: Fracture origin shown in Figure 7-39, exhibiting smooth cleavage facets (Stage I fatigue).

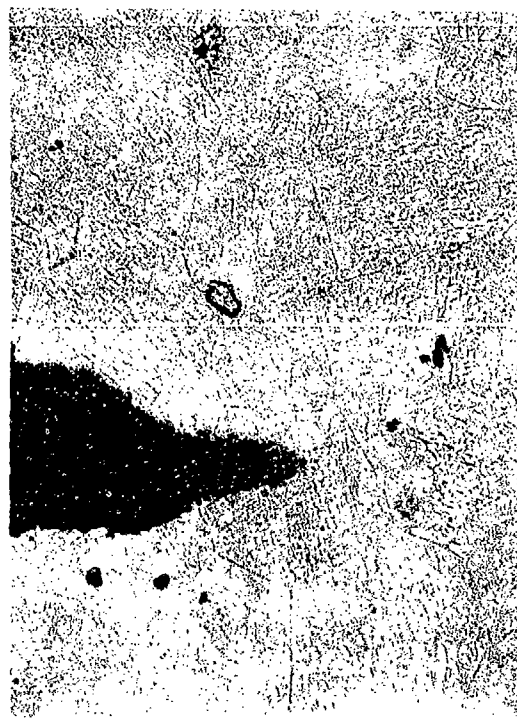
FAL 93461

FIGURE 7-81: Pair of optical photomicrographs of a metallographic cross section through several cracks. The cracks exhibit the oxidized wedge shape characteristic of TMF.

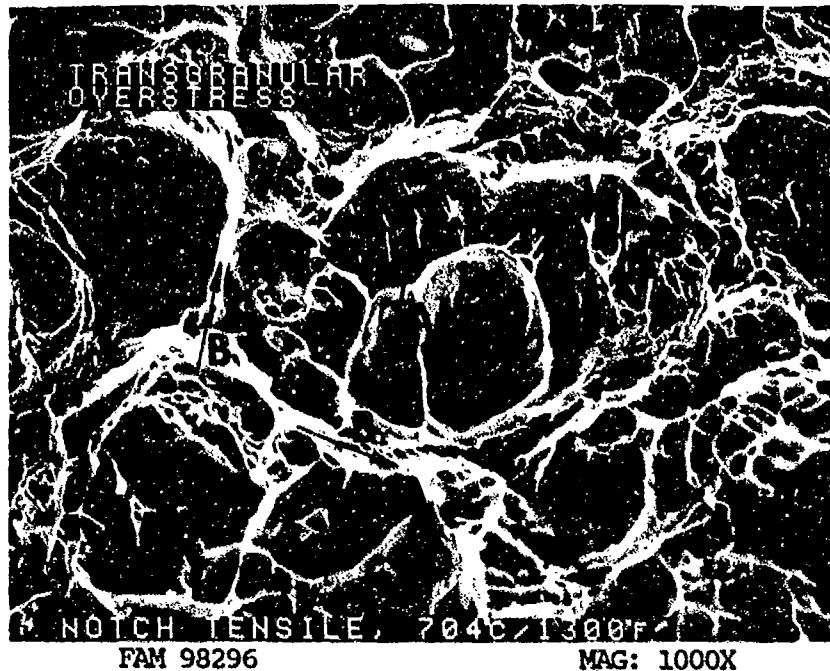
FIGURE 8-25: Transgranular cleavage overstress with some fine dimples. Slip lines are visible on some of the cleavage facets (arrows A). Tear ridges separate the areas of cleavage (arrows B).

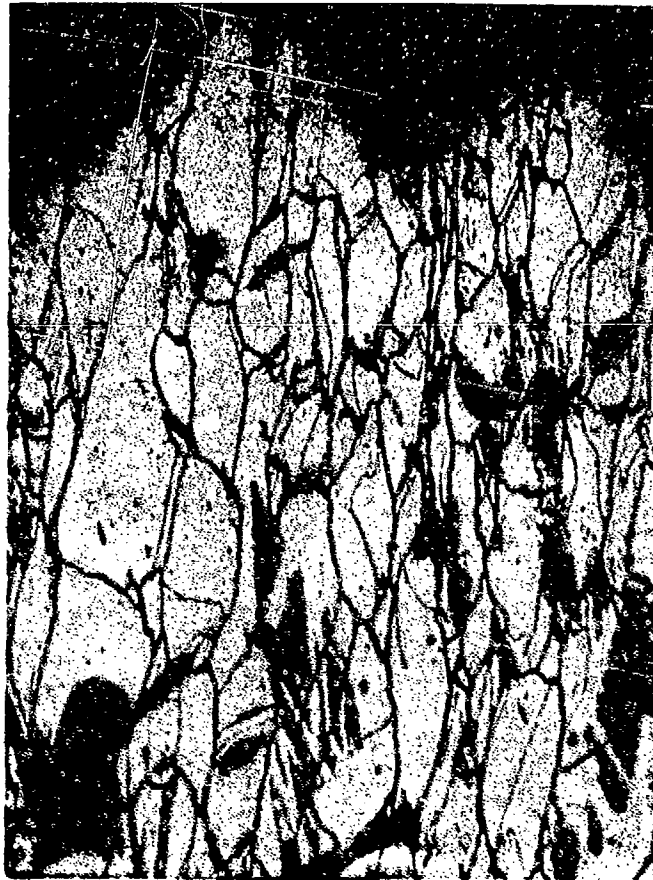
FAM 99841

FIGURE 8-30: Optical photomicrograph taken near the center of the specimen. The grains are larger than in the tensile specimens and, like the smooth tensile specimens, exhibit plastic deformation. In addition, secondary grain boundary separation is visible.

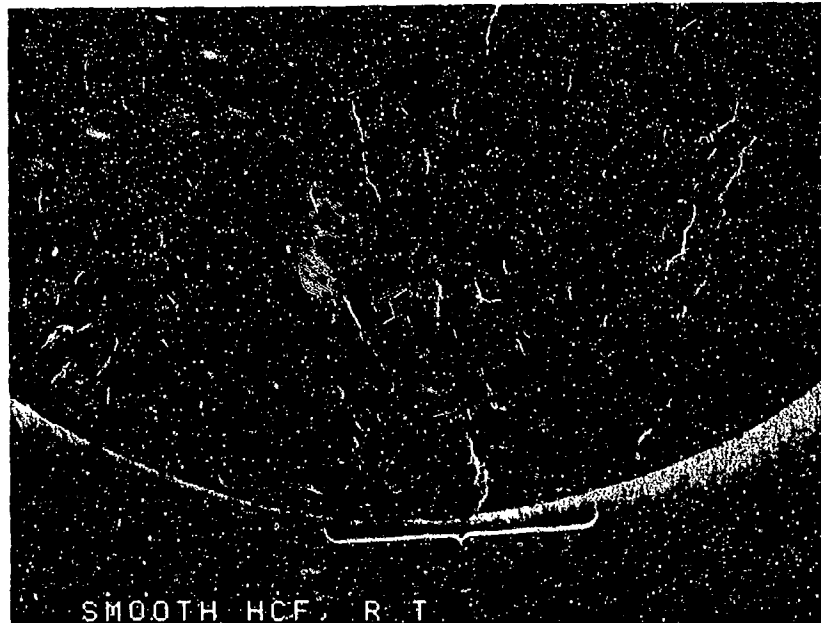
FAM 99297

FIGURE 8-37: Overall photograph of the origin area and initial fatigue progression zone. The fracture propagated from a relatively localized origin area but not from a point origin. Features are visible radiating from the area (bracket).

FIGURE 8-59: Higher magnification photograph of the localized origin area. The fracture appears relatively flat near the origin. Compare the appearance of this single origin with the diffuse origins on the room temperature and 800°F specimens (Figures 8-37 and 8-47).

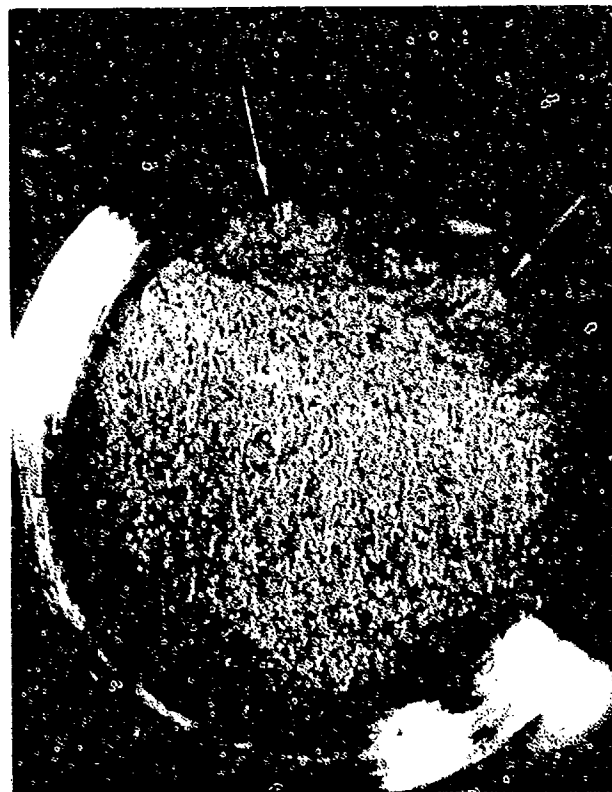
FAL 94245

FIGURE 8-77: Test results and fractography of Inconel 600 427°C (800°F) notched HCF test. The specimen exhibits fatigue progression over 80 percent of the fracture. Fatigue steps are visible at the surface of the specimen indicating propagation from multiple origins. The final overstress area is indicated by arrows.

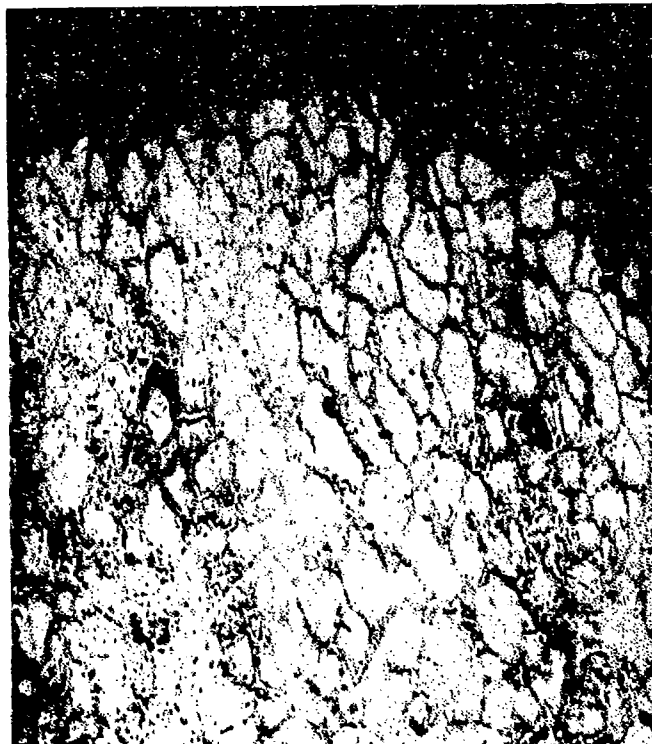
FIGURE 88: Optical photomicrographs showing fatigue progression area (top) and final overstress area (bottom). Compare the appearance of the grain boundaries with those in Figure 8-78, tested at 800° F.

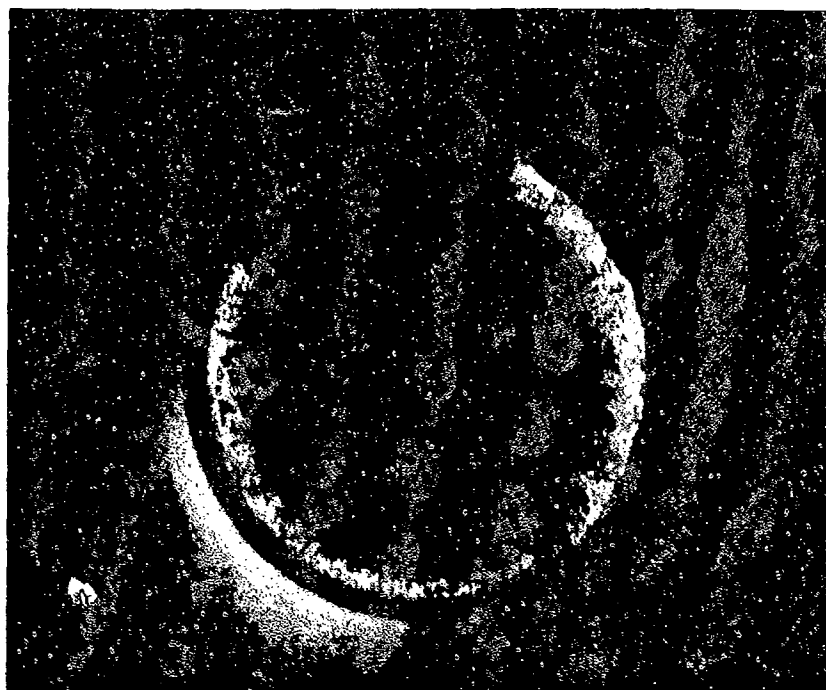
FAL 92553

Figure 9-1: Test results and fractography of Inconel X-750 room temperature smooth tensile test. The final overstress area (shear lip) appears shiny due to smearing. The center of the specimen has a granular appearance.

FIGURE 9-9: Test results and fractography of Inconel X-750 593°C (1100°F) smooth tensile test. The shear lip (bracket) is larger but not as clearly defined as on the room temperature specimen (Figure 9-1).

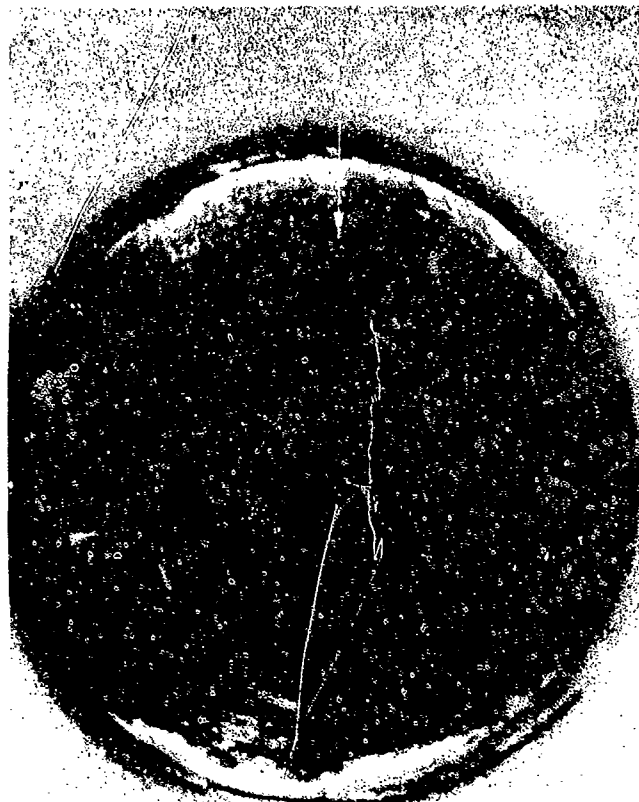
Ultimate Strength: 1378.9 MPa (200,000 PSI)

FIGURE 9-23: Test results and fractography of Inconel X-750 593°C (1100°F) notched tensile test. A discontinuous narrow shear lip is visible along the surface (arrows). The specimen appears oxidized.

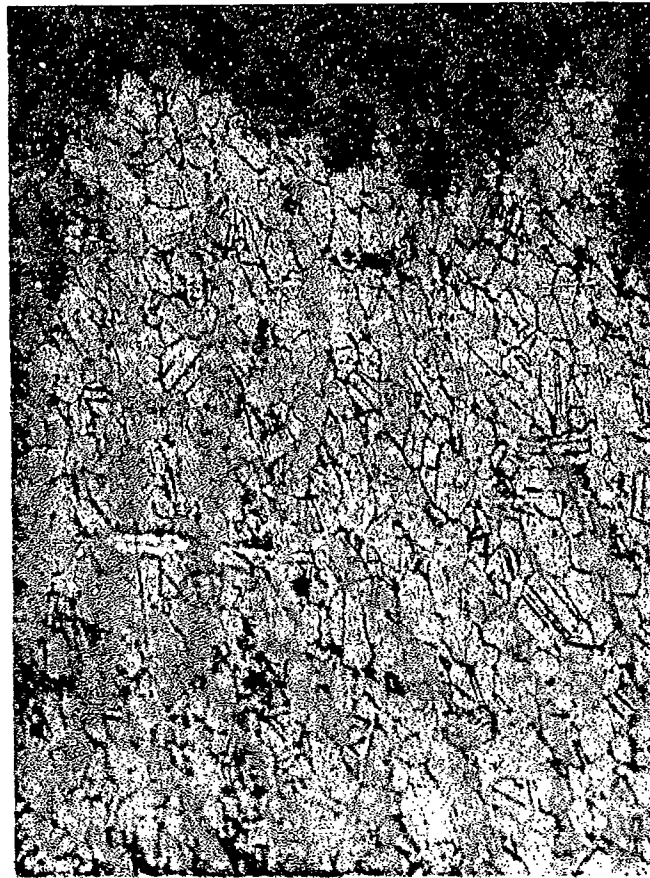
FIGURE 9-24: Optical photomicrograph showing the primary fracture area on the left side of the photograph and the final overstress area (shear lip) at the base of the notch (arrow) on the right side of the photograph. The fracture propagated predominantly in an intergranular mode. The grains in the final overstress area exhibit some plastic deformation.

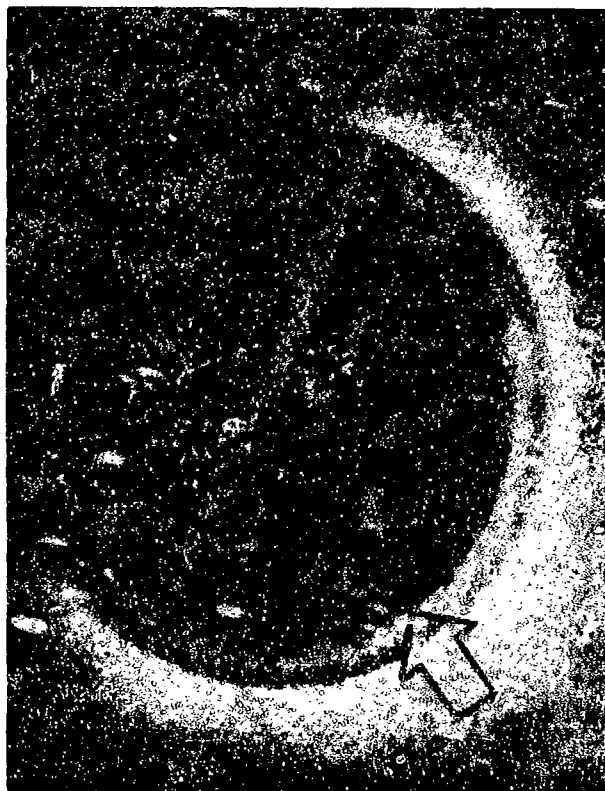
FIGURE 9-57: Test results and fractography of Inconel X-750 593°C (1100°F) smooth HCF test. The fatigue progression area appears generally darker (more oxidized) than the final overstress area. An arrow indicates the origin area. No clear boundary exists between fatigue and final overstress areas.
